# The Ladbroke Grove Rail Inquiry

## Part 1 Report

**The Rt Hon Lord Cullen PC**

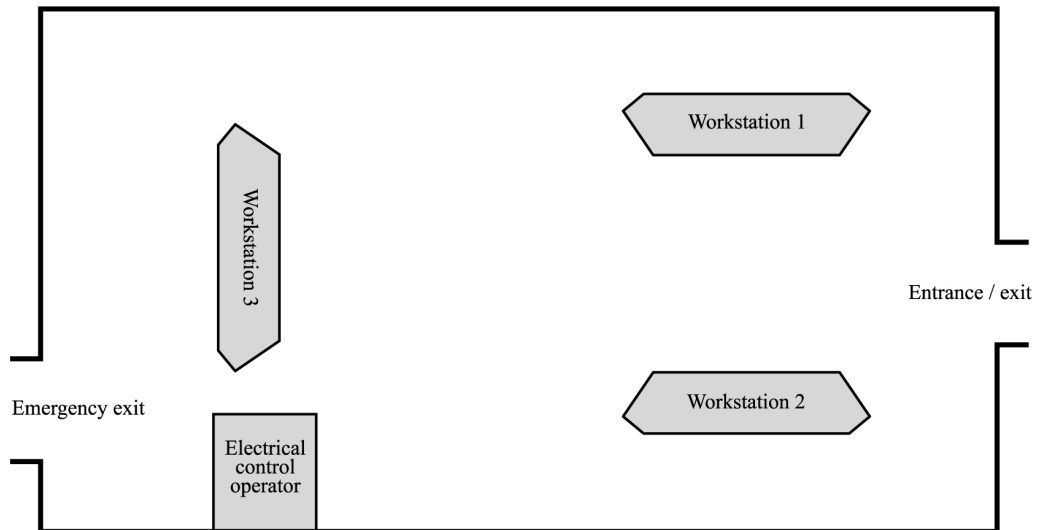
**Diagram 1a:** Layout of the Slough IECC work room

- 6.3 Stage 1 of the IECC was commissioned in July 1993 at the same time as the signalling which it controlled. The control room at the IECC contained three workstations. Workstation 1 controlled the area from Paddington Station to Acton East. Workstation 2 controlled the area from Acton East to West Drayton. Workstation 3 was the position for signal support. There was a separate desk for the electrical control operator. The premises also included a kitchen, mess room and toilet (*see Diagrams 1a and 1b overleaf*).

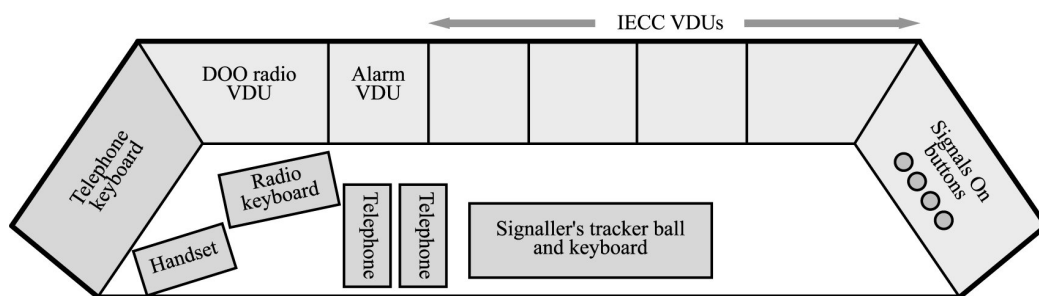
**Diagram 1b:** Layout of workstation at the Slough IECC

- 6.4 Each of workstations 1 and 2 contained eight segments, which comprised, from left to right as seen by the signaller, control buttons for the telephone concentrator (mainly signal post telephones), the visual display unit (VDU) for the telephone concentrator, the VDU for the IECC alarms, four segments containing VDUs which were capable of displaying schematic diagrams of the layout of the signals, track circuits and points in various sub-areas, and six "emergency all signals on" buttons which were set out in a

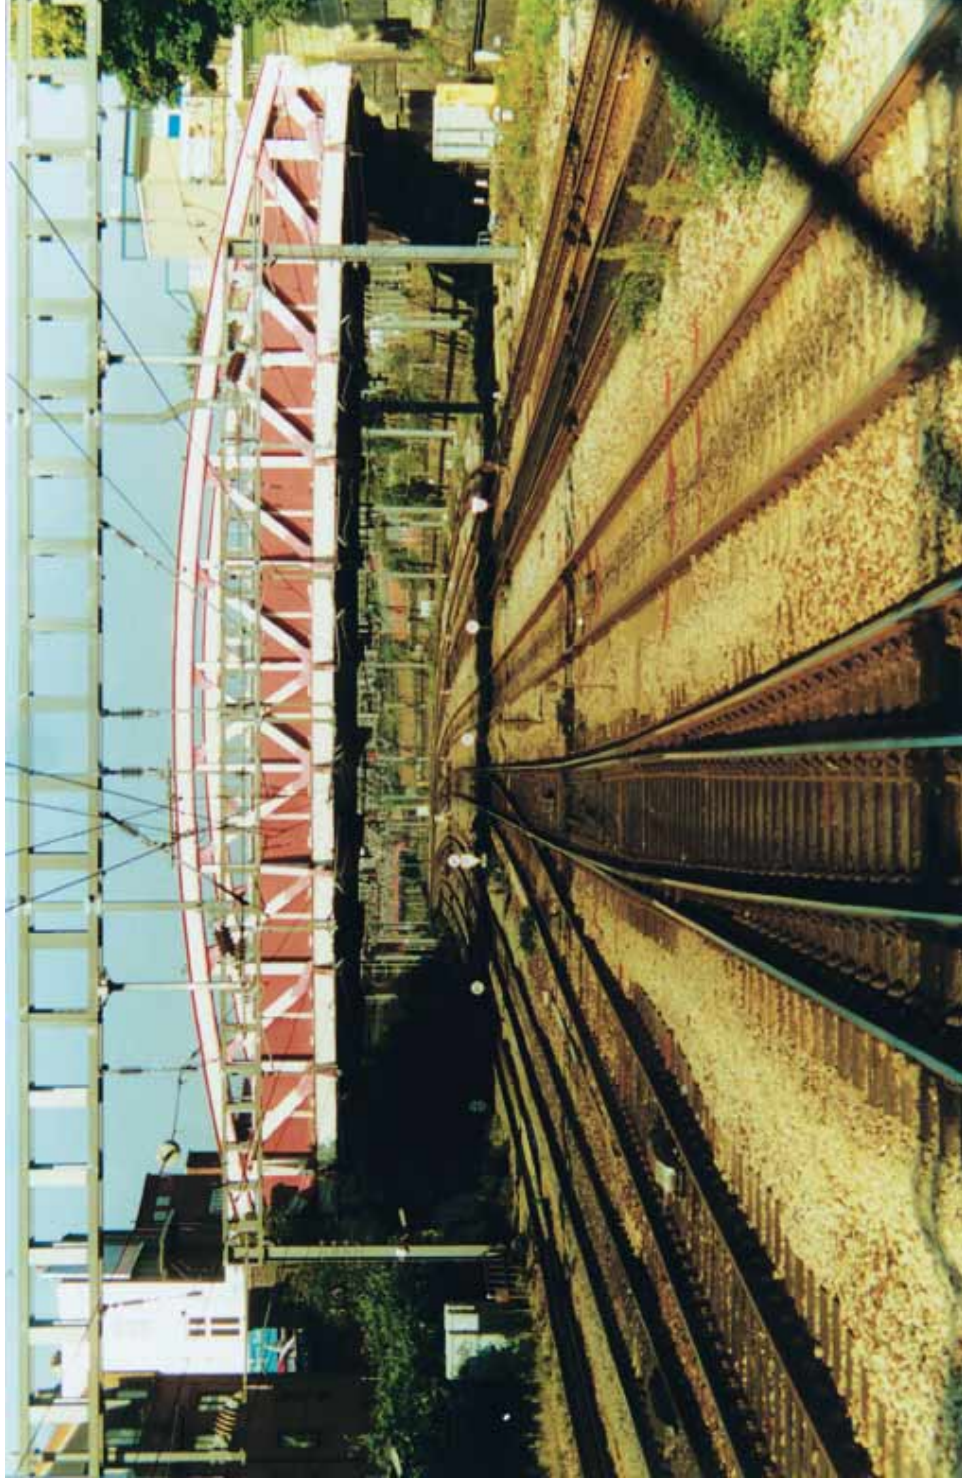
**Plate 2:** Gantry 8 at a distance of 218 metres. Taken from the driver's position in a Class 165 Turbo on the Line 4 to Line 3 crossover. Its signals, from left to right, are SN107, SN109, SN111, SN113 and SN115. SN105 is carried by a post at the trackside.

- 3.11 On leaving Paddington the lines curve to the left and then run straight as far as Royal Oak where a long right hand curve begins. On the approach to Westbourne Park where signal SN87, referred to in para 3.17, is situated, the line straightens briefly before curving again to the right (*see Plate 1*). The line then runs straight until a long left hand curve begins approximately 80m before signal SN109, referred to in para 3.19 (*see Plates 2, 3, 4 and 5*).

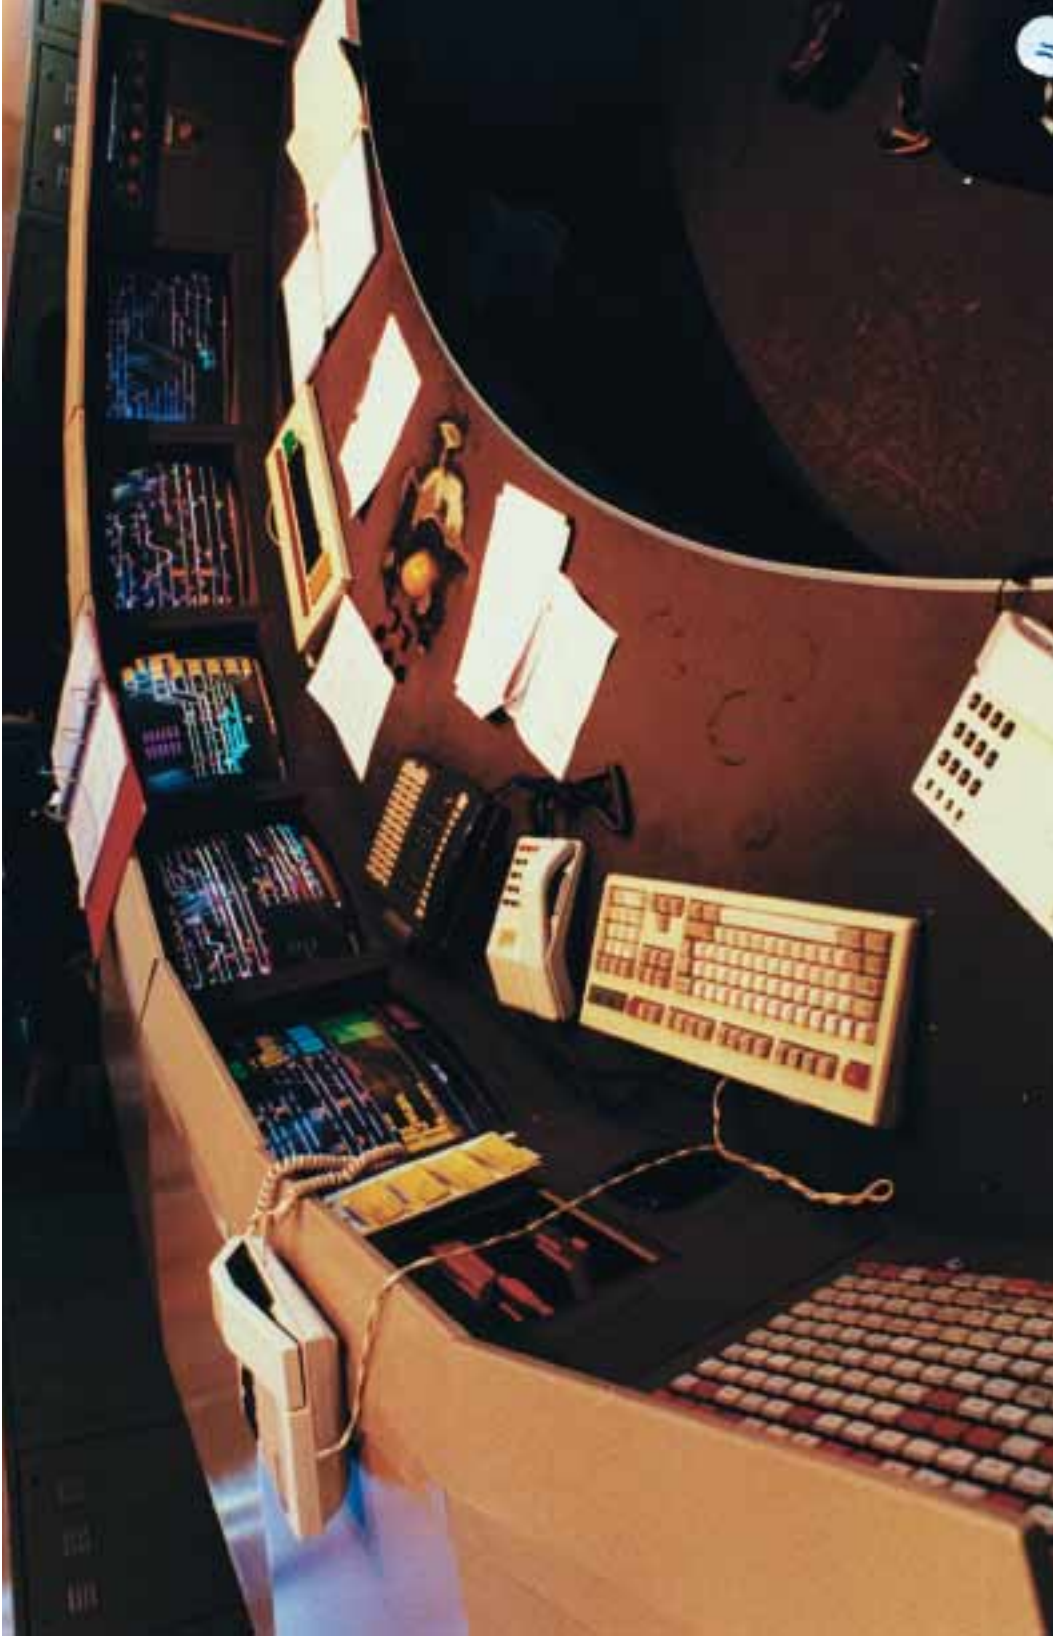
*Plate 15:* Workstation at IECC, Slough.

horizontal row. On the desk of each workstation were a radio keyboard and handset, two telephones, and a tracker ball with control buttons and a keyboard (*see Plate 15*).
